Evaluation of ceramic veneer adaptation by optical coherence tomography: a clinical report

Luís Fellype Moraes CASTELLO¹, Nathalia Del Rio Lyra GRAÇA¹, Luana Osório FERNANDES¹, Marlus da Silva PEDROSA³, Anderson Stevens Leonidas GOMES⁴, Claudio Heliomar Vicente da SILVA²

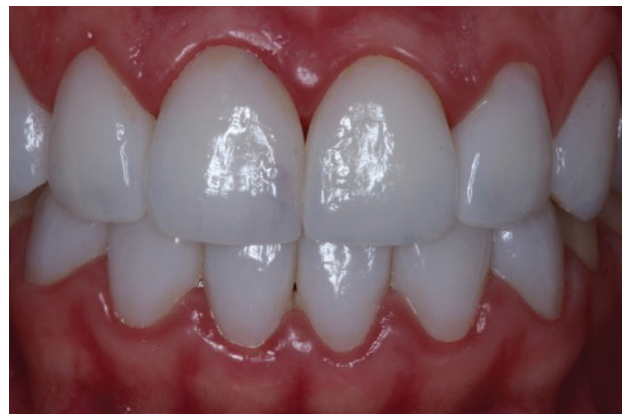
A 24-year-old female patient complained of unsatisfied color change in the ceramic veneer placed on the right maxillary central incisor. This was observed through visual inspection (Figures 1 and 2). The OCT sagittal images showed the presence of gaps or bubbles with a suggestive aspect of cooptation (Figure 3).

Figure 1 - Intraoral front view photograph of the patient's smile showing color changes in the ceramic veneer of the right maxillary central incisor.

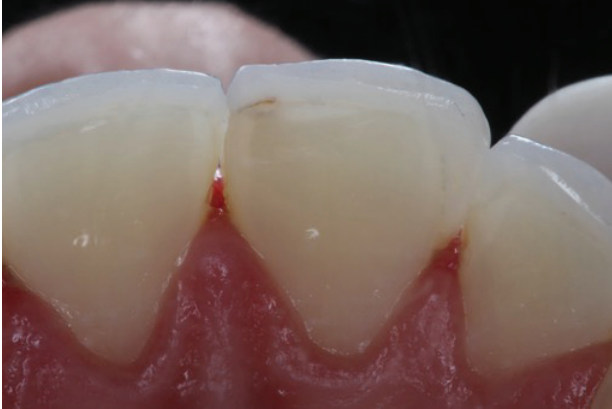
Figure 2 - Palatal view of the right maxillary central incisor.

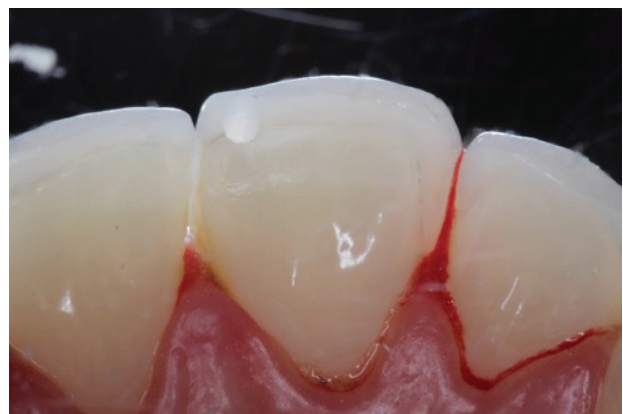
Figure 4 - Palatal front view of the right maxillary central incisor after intervention with diamond bur.

The patient signed the informed consent for the proposed treatment, which consisted of repair of the restoration by infiltration of a composite resin. With the location of the bubble, the defective tooth-restoration interface was accessed using a diamond bur with pointed cone shaped spear (#2140, KG Sorensen, Brazil) (Figure 4). Etching was carried out with 37% phosphoric acid (Super Etch, SDI, Australia) for 30s. The surfaces were washed with distilled water for 30s and dried with air. Silane (Monobond Plus, Ivoclar Vivadent, Liechtenstein) was applied on the ceramic veneer surfaces for 1 min and dried with air. An adhesive system (Stae, SDI, Australia) was applied and light-cured for 20 s (Radii Plus, SDI, Australia). A B1 flowable composite resin (Wave, SDI, Australia) was injected (Figure 5) and light-cured for 40 s (Radii Plus, SDI, Australia). The occlusion was checked and finishing and polishing procedures were carried out with Sof-Lex™ Pop-On discs (3M, Saint Paul, Minnesota, EUA). The patient was satisfied with the achieve result (Figures 6 and 7). Figure 8 shows the OCT sagittal images of the element 11 after repair.

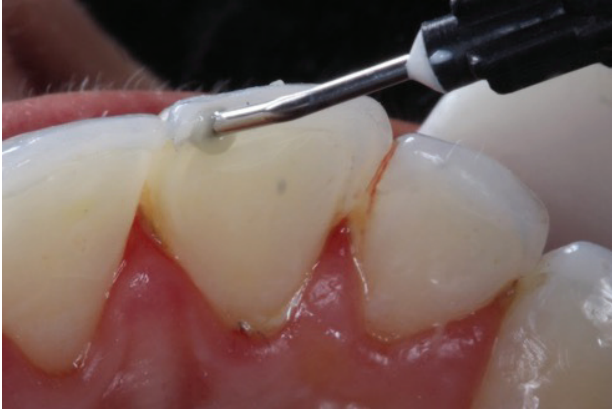
Figure 5 - Application of a B1 flowable composite resin.

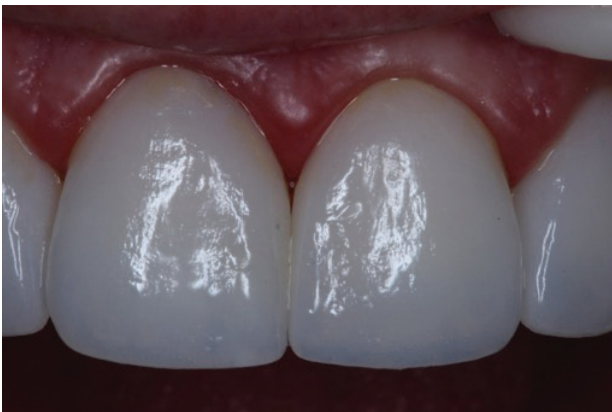
Figure 6 - Intraoral front view of the patient's smile after repair.

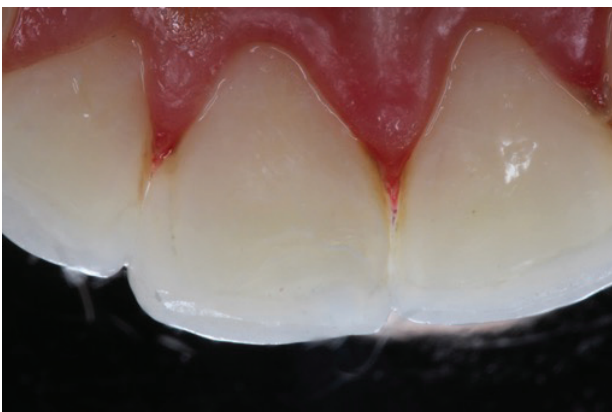
Figure 7 - Palatal view of the right maxillary central incisor after repair.
