An evaluation of the effect of different veneer materials on fracture resistance of zirconia core

Yousra A IBRAHEEM¹, Zahraa N ALWAHAB¹

1 - Department of Dental Technologies, College of Health and Medical Technologies, Middle Technical University, Iraq.

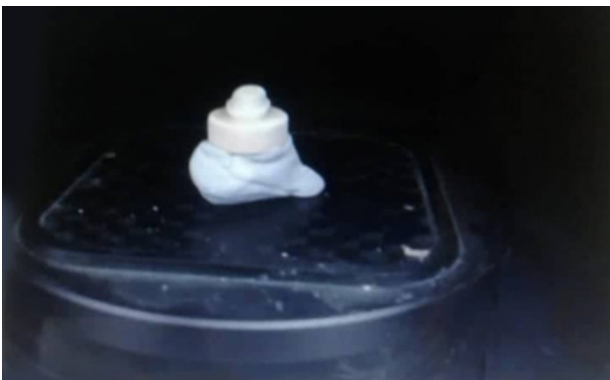
Figure 1 - Metal die inside scanner.

The base for the metal die was constructed from dental stone type IV to allow proper position of the metal die during scanning. Two grooves were made in the bottom of the metal die for retention of the stone base to the metal die. The dental stone was blended depending to manufacturer guidelines the dental stone was blended (100 g powder/ 20 ml water), vibrated, and poured to 4 mm below the cemento-enamel junction [10] (Figure 1). The stone base was separated from the plastic ring after 40 min according to the manufacturer's instructions. The metal die was surface scanned in the same way as in scanning of plastic die.
